# FINAL REPORT

**On the investigation of a serious accident on July 16<sup>th</sup>, 2018, by McDonnell Douglas MD-82 aircraft, registration LZ-LDM, upon approach for landing on the Tarbes–Lourdes–Pyrénées Airport, France**

**Aircraft Accidents Investigation Unit AAUI  
Republic of Bulgaria**

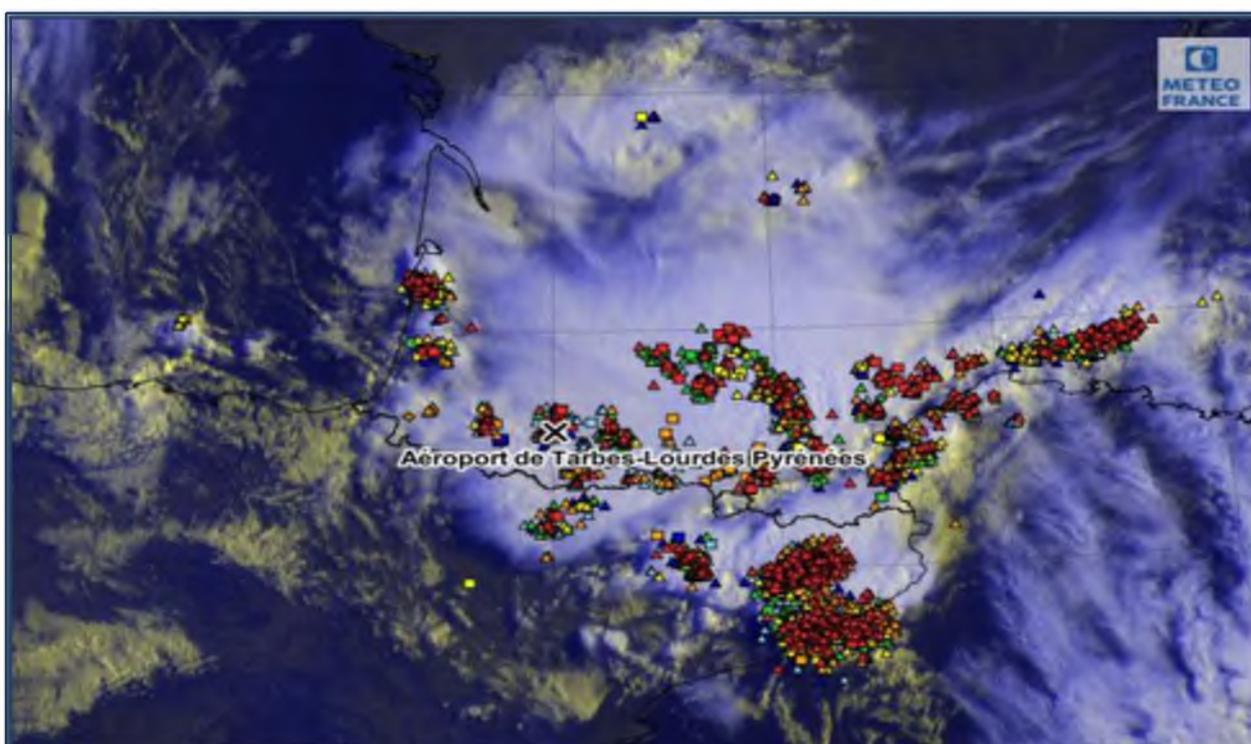
Figure 6

The picture shows the radar mosaic of conditions (in color reflection) with the lightning spots (orange-red symbol) at 07:30 UTC.

When zooming the picture around the airport area, we see a significant intensity of conditions in the Northern area of the airport.
