FINAL REPORT

Investigation of a serious incident, occurred on July 25, 2018 at Burgas Airport, Bulgaria, involving the McDonnell Douglas MD-82 aircraft, registration marks LZ-LDW, operated by „Bulgarian Air Charter Ltd“, during passenger embarkation

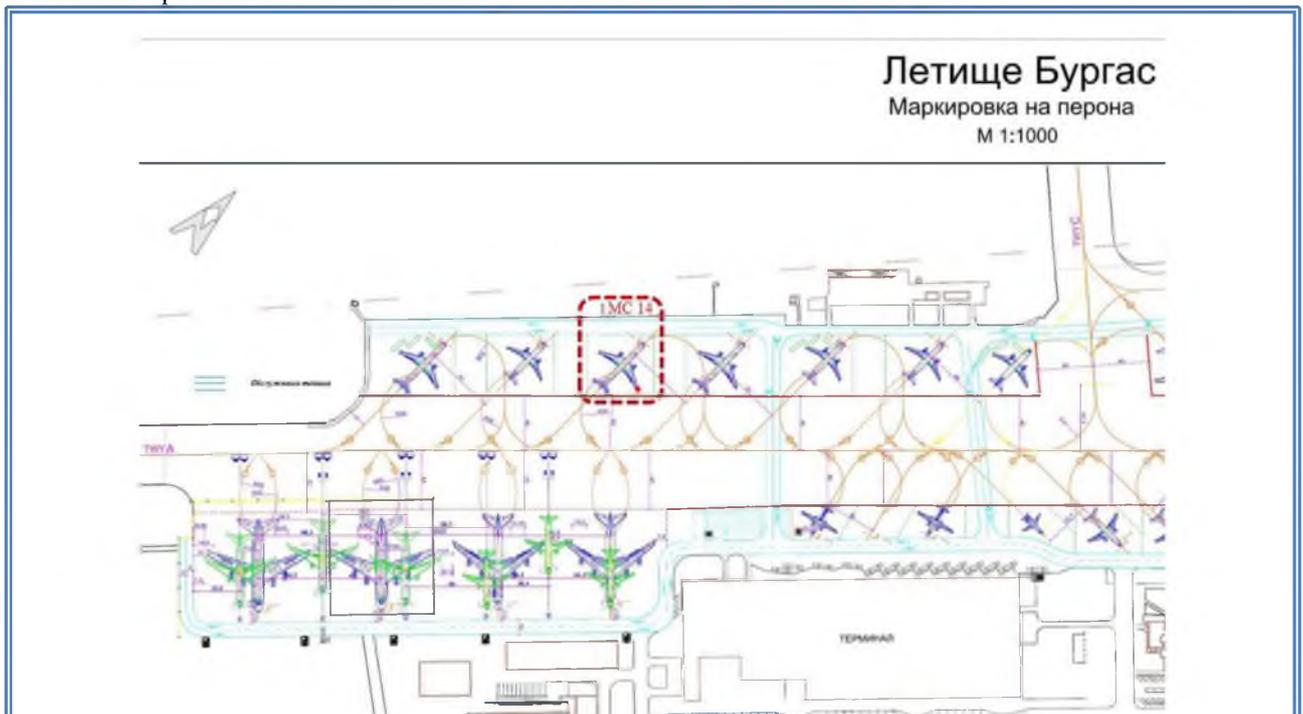
Fig.2 – Burgas Airport apron marking

Location	Burgas Airport (LBBG) Bulgaria, Aircraft stand No 14;
Date and time:	25 July 2018, 02:18:37 UTC;
Lighting conditions:	Night;
The control point is with coordinate's	42°34'13"N 027°30'55"E.

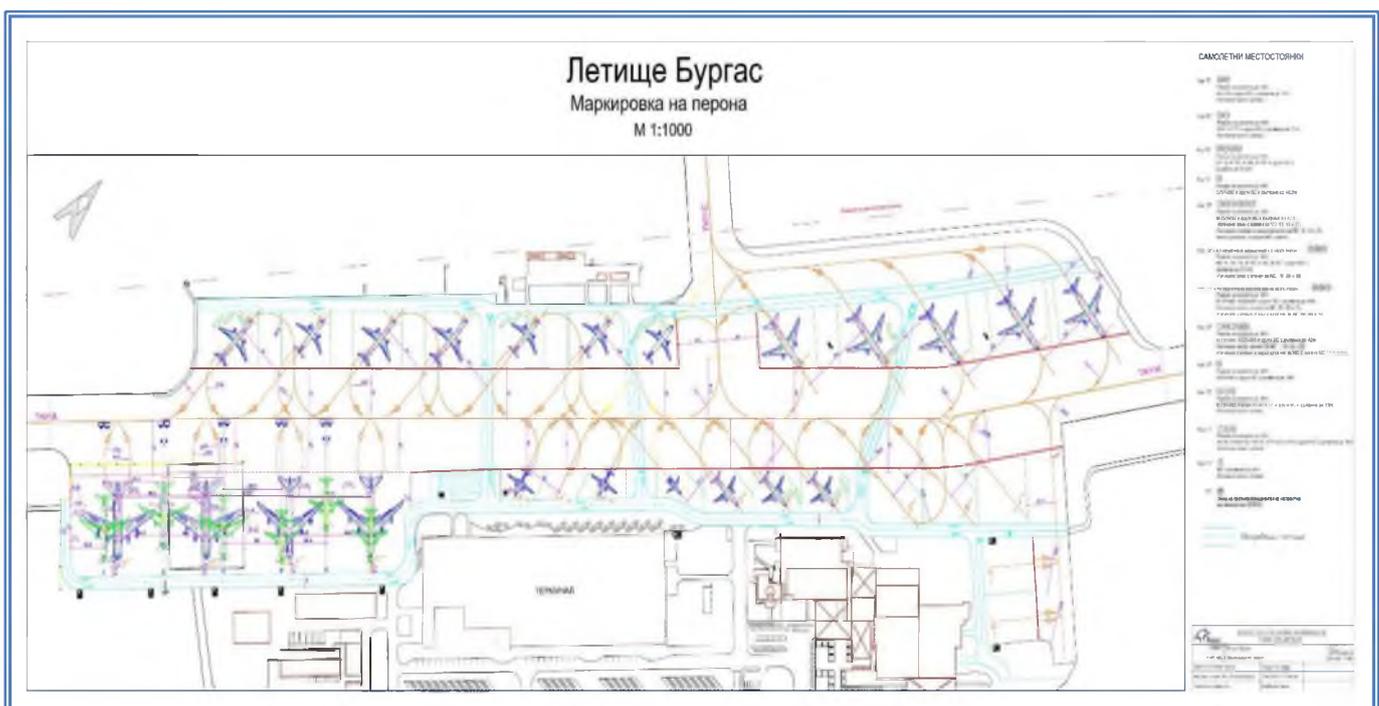
Fig.5-Burgas Airport apron marking

Aerodrome Location Indicator and Name – LBBG-BURGAS;
ARP coordinates and site at aerodrome - N42°34'13" E027°30'55", RWY centre;
Elevation - 135 ft. (44 m);
Designations / RWY 04/22 - MAG 040°/220°;
Dimensions of RWY (m) - 3200 x 45 m;
The apron bus approached to the aircraft stand on the apron path for movement, with observing of the maximum authorization velocity for moving of vehicles on the apron
