# **FINAL REPORT**

**investigation of an accident, realized on 09.05.2020 with a JA 600 aircraft (SKYLEADER 600), registration marks LZ-ACS, operated by a pilot owner, during landing on the Lesnovo Airfield**

**2020**

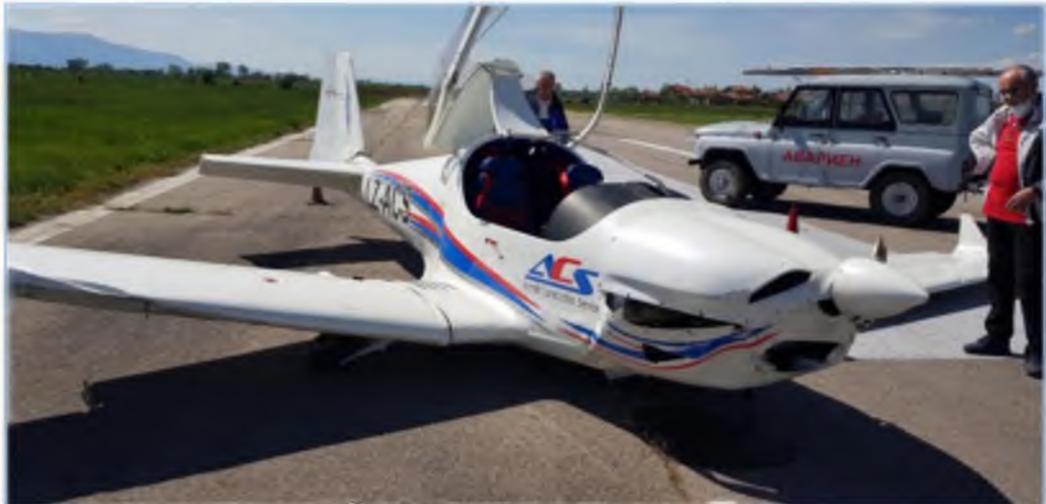
Fig. 2.

The above can be seen in Fig. 2, 3, 5, 6, 7, 8, 16, 17, 18, 20 and 23 of Enclosure 1.

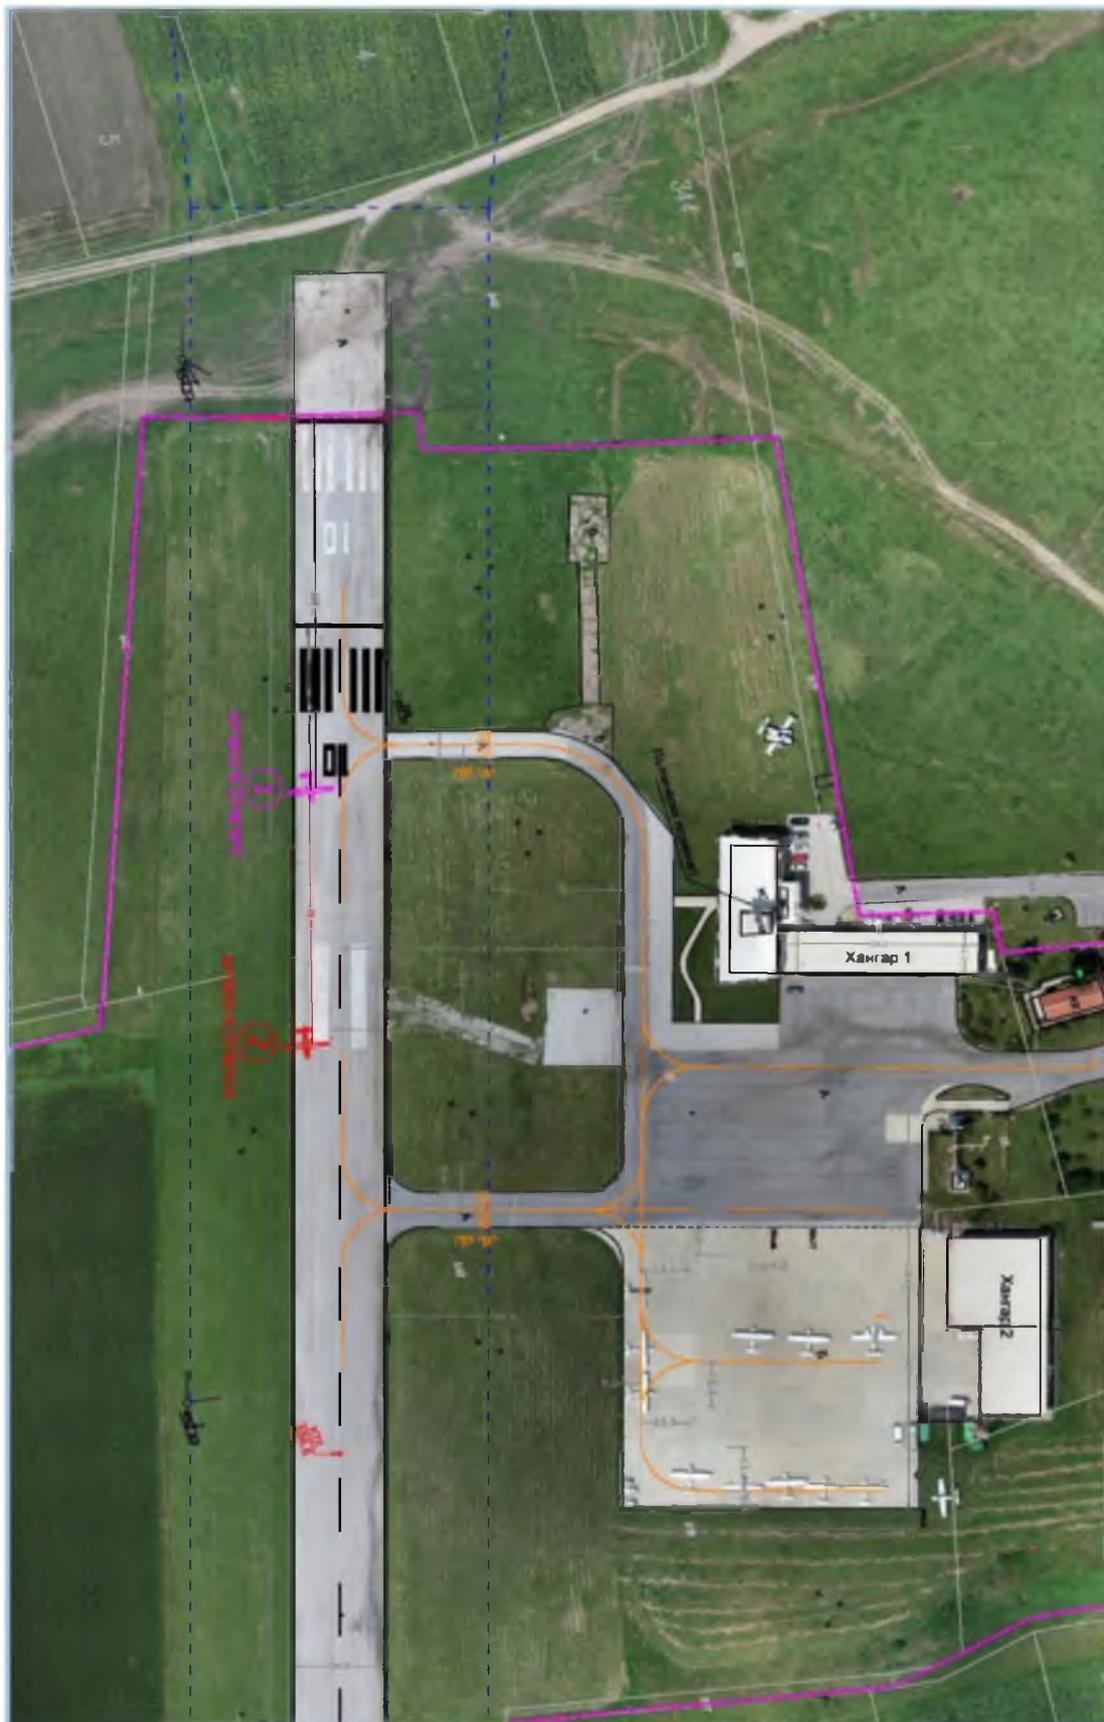
Fig. 27.

The trajectory of the aircraft at the last stage of the flight is shown in the two figures on page 18 of Enclosure 2, constructed on the basis of the database referred to in paragraph 2.11. The aircraft flew almost perpendicular to runway 10 in continuous descend. The pilot extended the landing gear in the immediate vicinity of the runway and tried to steer it along the runway axis. From a height of about 7 m (according to eyewitness information), the plane stalled to the right-hand wing, and touched down on this wing the RWY10 at 105 m from the threshold at a point with coordinates 42°38'02"N and 23° 38'39" E. The traces of touching are shown in Fig. 1 of Enclosure 1. At touchdown the landing gear of the aircraft was not completely extended, the right-hand semi-wing lost its structural integrity, breaking at a distance of about two-thirds of its base, as shown in Fig. 3 of Enclosure 1. The right-hand landing gear bended towards the outer edge of the semi-wing, and the nose landing gear was also bended. According with paragraph 3.3 of the POH, the landing gear extending time is 20s. The aircraft suffered the damages as described in paragraph 2.3 and stopped at 177m of the threshold of RWY10, a point with coordinates 42°38'01"N and 23°38'48 E, elevation 556 m (1827ft). The plane glided 72 m along the runway. These distances are indicated on the diagram shown in Fig. 27 of Enclosure 1
