FINAL REPORT

Investigation of a serious incident, realized on 14.08.2019 by Cessna 172N airplane, registration marks LZ-SPB, operated by Air Operator Avio Detachment Varna Ltd on Lesново Airfield, District of Sofia

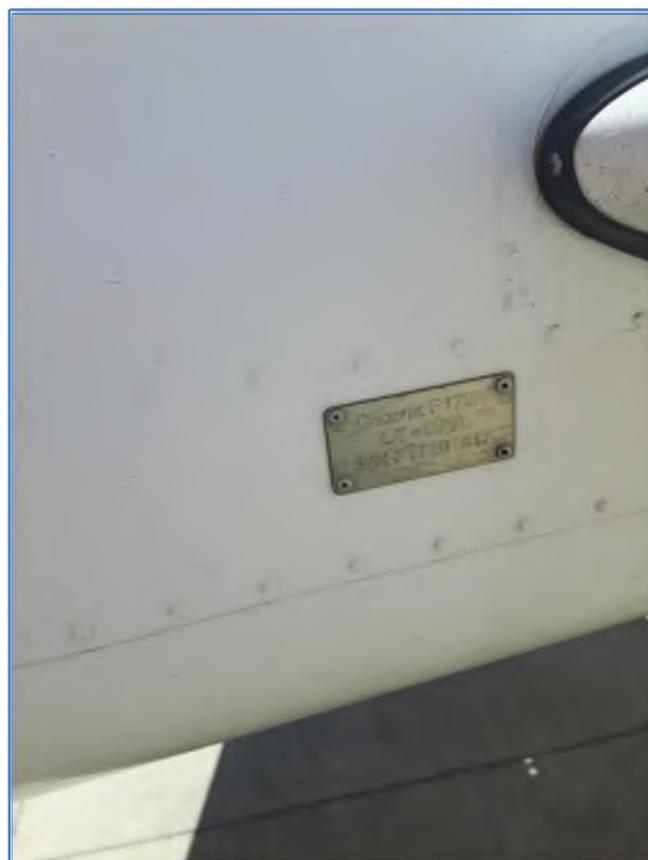
Fig. 3.

An Cessna F172N aircraft, registration marks LZ-SPB, was manufactured in 1979 by Reims Aviation Cessna, Republic of France. The serial number, written on the identification plate of the aircraft, shown on Fig. 3 of Annex 1, is F17201817. The airplane possesses a Certificate of Registration No.2523 issued by the Directory General of Civil Aviation Administration of the Republic of Bulgaria on 07.10.2014 and in this certificate the serial number is written as F172-1817. The aircraft is owned by Avio Detachment Varna Ltd with office address V. Varnenchik residential complex, block 401, entrance 17, ap. 288, Varna, Republic of Bulgaria. Aircraft operator is Avio Detachment Varna Ltd with office address Vladislav Varnenchik residential complex, block 401, entrance 17, apartment 228, Varna 9023, Republic of Bulgaria.

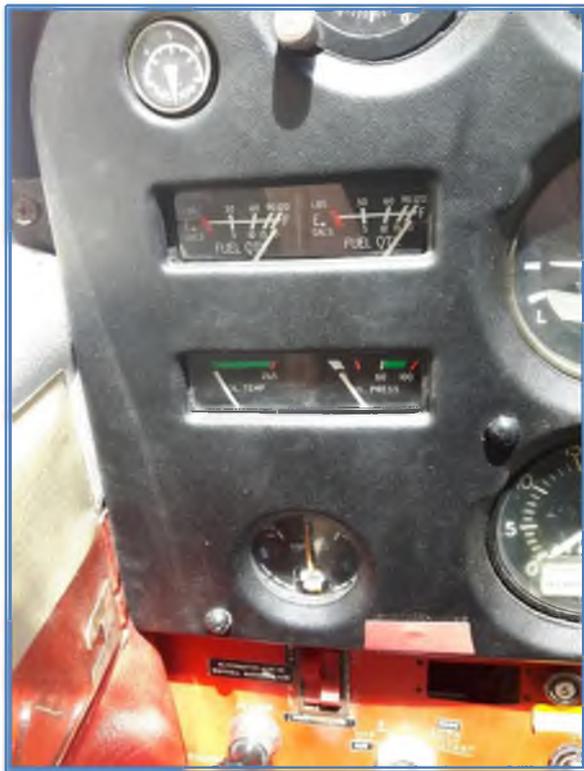
Fig. 5.

A picture of the fuel indicators are shown on Fig. 5 of Annex 1; the total fuel quantity was 108 kg

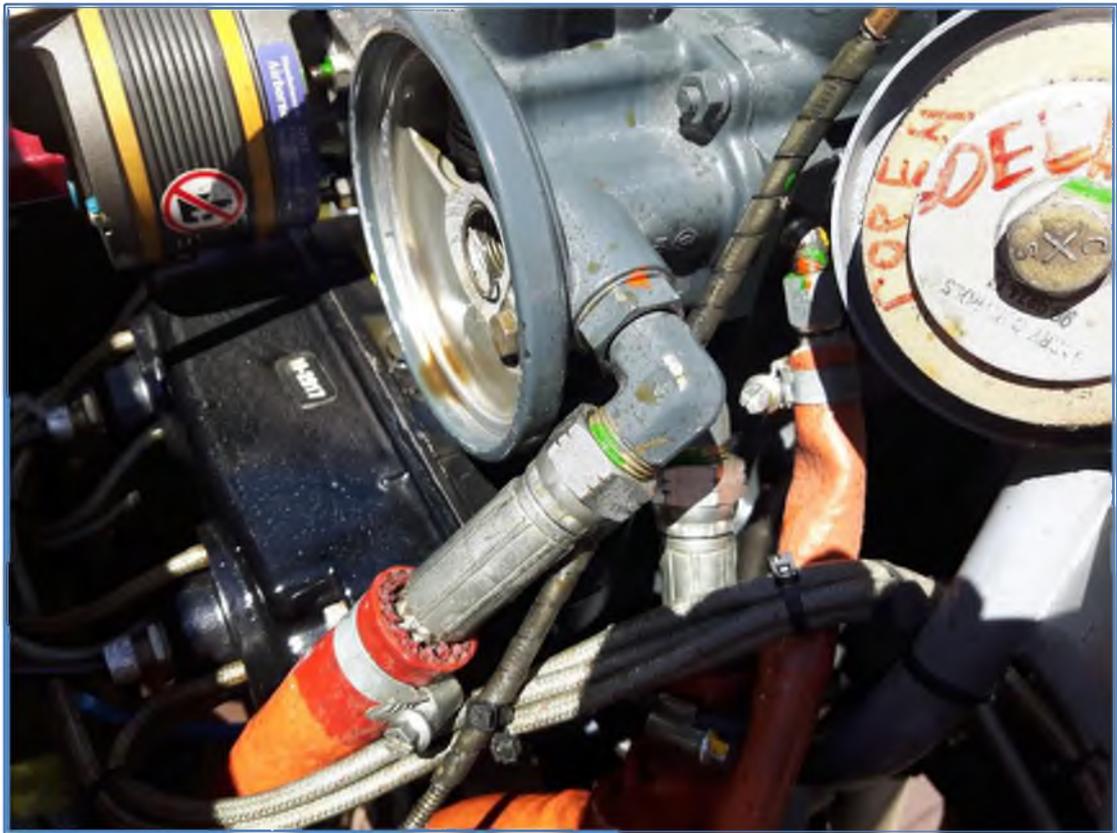
Fig. 11.

- There were traces of oil leakage under the airplane and all over the lower surface of the airframe;
- The oil filter was torn from the adapter plate and attached by the locking wire only, as shown on Fig. 10 of Annex 1;
- Destruction of mounting assembly of the adapter plate at the crankcase, Fig. 11 and 12 of Annex 1;
- Demolition of the valve lifter housing of the outlet valve of fourth cylinder, shown on Fig.13 of Annex 1;
- The mark on the dipstick for controlling the actual amount of oil shown in Fig. 9 of Appendix 1, evidenced of complete leakage of oil, and 200 ml of oil were drained from the crankcase.

The fractographic analysis has shown that the destruction of the filter was likely to have started as a plastic fracture in the cross section of the adapter sleeve about 50% and the final breakage was a brittle fragile. On the Fig. 10, 11, 12, 14, 15, 18 и 23 are shown pictures of this destruction. Para2.12 states the findings after disassembling of the detached filter assembly. When considering the outcome of the fractographic analysis and the findings made during disassembly, several possible scenarios related to the destruction of the assembly might be identified. For each of them there is a certain effect of reducing to some extent the area of the bearing cross section of the sleeve, associated with the insertion of the helical spring to form the inner thread of the sleeve. As it was indicated in para2.12, such a spring may be fitted during the engine overhaul.
