FINAL REPORT

Investigation of a serious incident, occurred on February 26, 2018 at Sofia Airport, Bulgaria, involving the AIRBUS 321-231 aircraft, registration marks HA-LXP, HA-LXL and HA-LXD, operated by “Wizz Air”

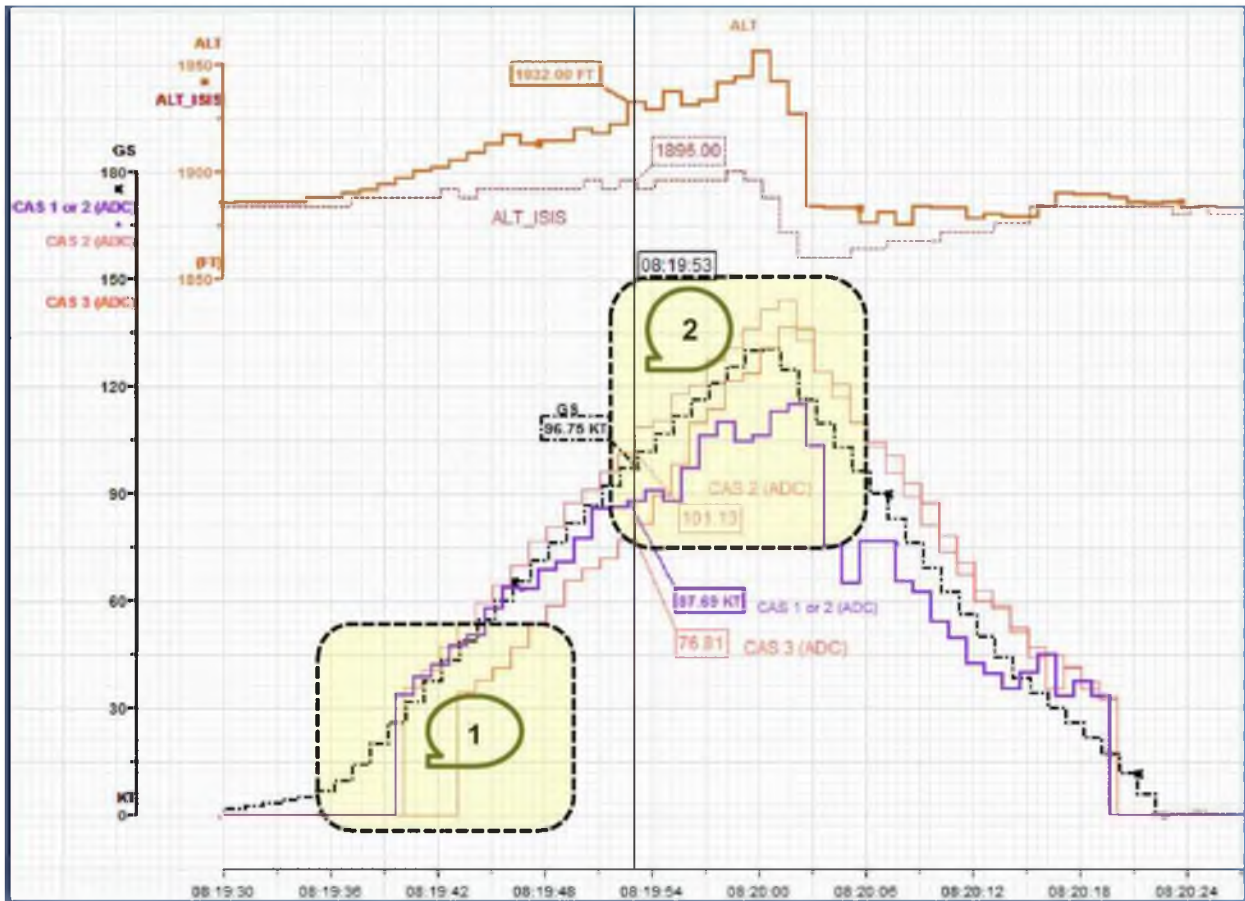
Plotted data / Speed and Altitude data

Initial conditions at 08:19:38 UTC:

- - A/C was aligned on RWY 09
- - A/C was in CONF 2
- - BRKMAX recorded at 1
- - Thrust Levers were pushed to TOGA notch
- - Both FDs engaged in SRS/RWY mode
- - A/THR was engaged and armed in THRUST mode
- - GS started to increase ;
- - CAS1 and CAS2 became valid at 08:19:39 UTC
- - CAS3 became valid at 08:19:43 UTC
- - SAT was recorded at -7°C

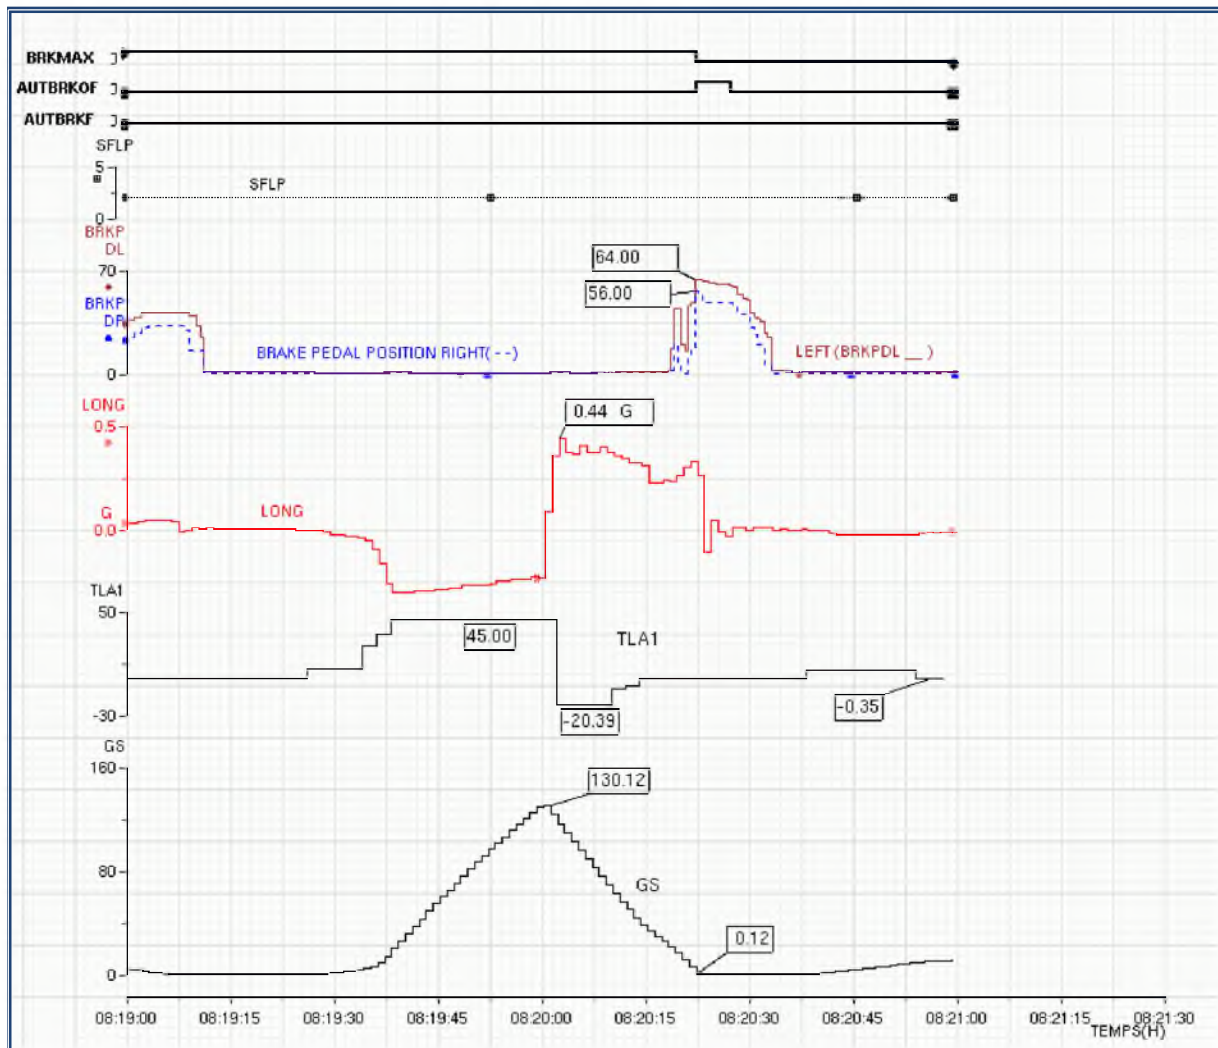
Rejected Take-Off

At 08:20:10 UTC:

- - Thrust Levers were set to IDLE notch.
- - Ground speed was recorded at 69kt,
- At 08:20:22 UTC,
- - BRKMAX recorded from 1 to 0
- - Brake Pedal Position left = 64 degA
- - Brake Pedal Position left = 55 degA
- - AUTBRKOF recorded at 1 during 5 seconds
- - A/C stopped (GS=0kt).

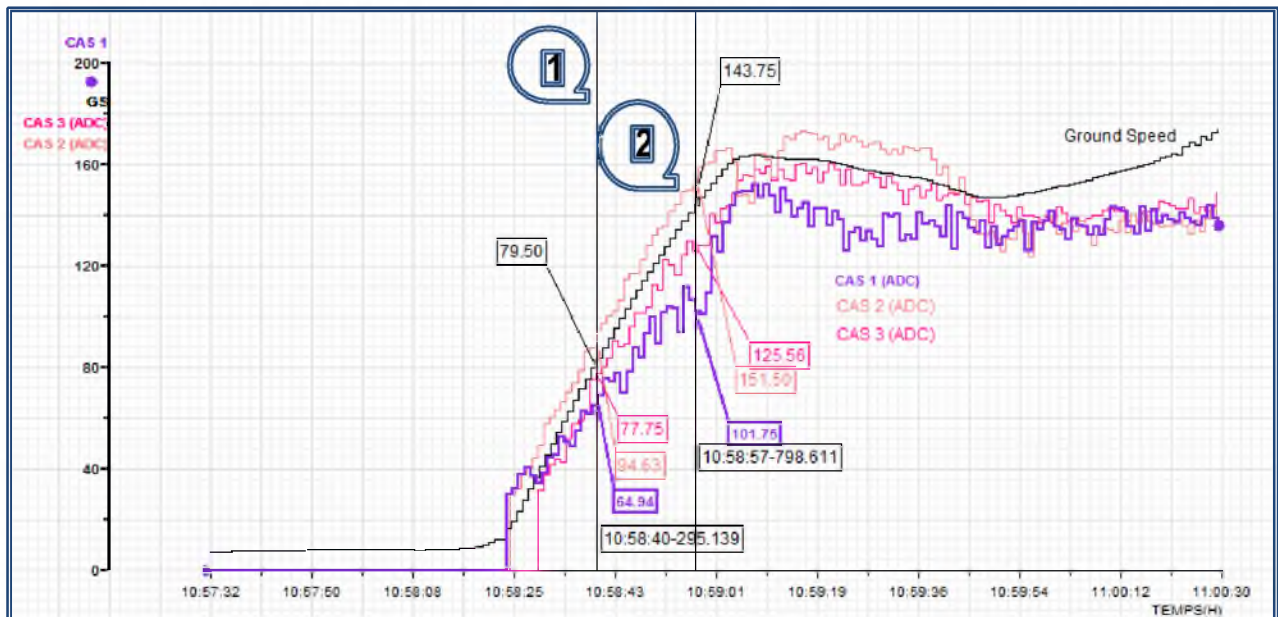
Plotted data / Take-Off

Initial conditions at 10:58:27 UTC:

- A/C was aligned on RWY 09 in CONF 2
- TLs were pushed to TOGA notch
- Both FDs engaged in SRS/RWY mode
- A/THR engaged and armed in THRUST mode
- GS and CAS started to increase
- SAT was recorded at -7.5°C
