FINAL REPORT

Investigation of a serious incident, occurred on February 26, 2018 at Sofia Airport, Bulgaria, involving the AIRBUS 321-231 aircraft, registration marks HA-LXP, HA-LXL and HA-LXD, operated by “Wizz Air”

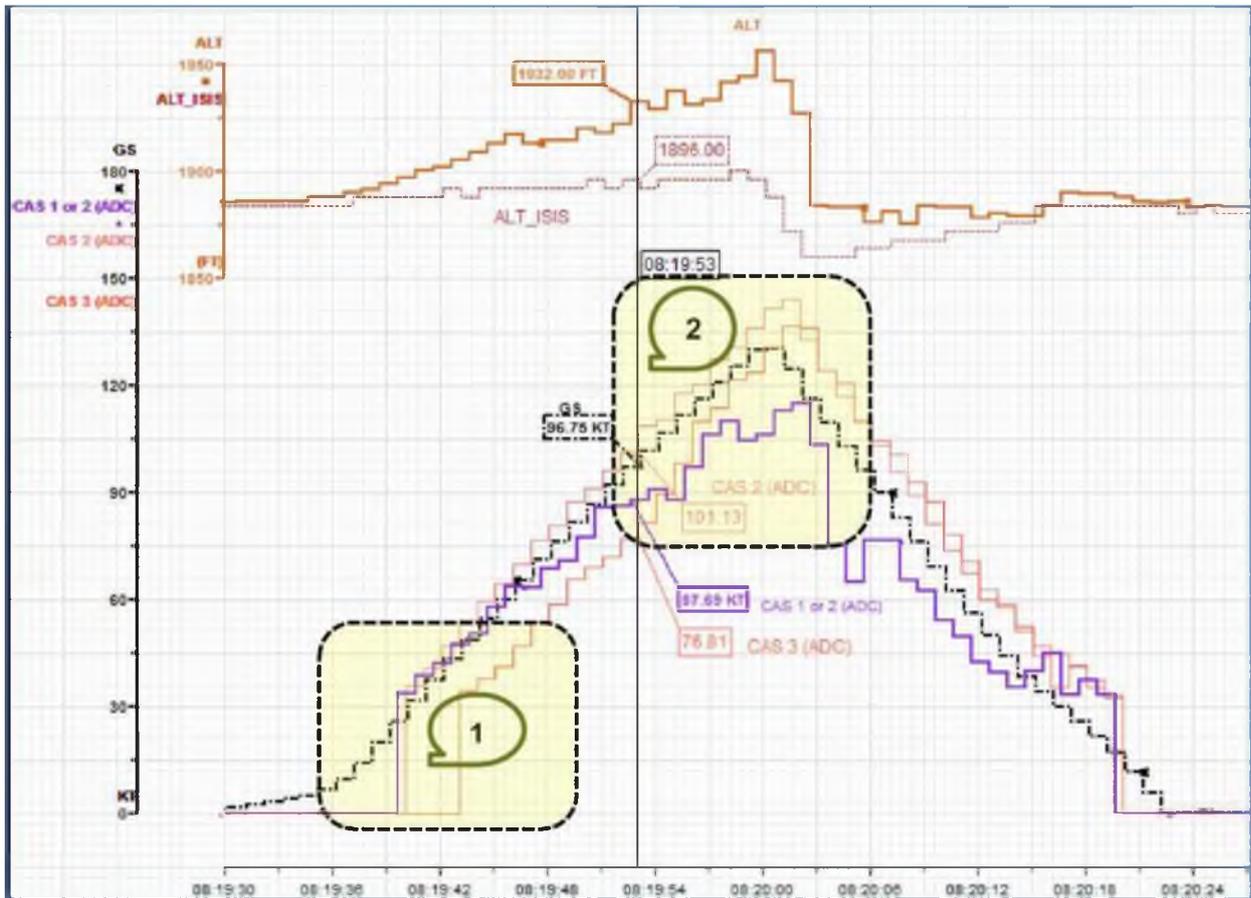
Plotted data / Speed and Altitude data

- - A/C was aligned on RWY 09
- - A/C was in CONF 2
- - BRKMAX recorded at 1
- - Thrust Levers were pushed to TOGA notch
- - Both FDs engaged in SRS/RWY mode
- - A/THR was engaged and armed in THRUST mode
- - GS started to increase ;
- - CAS1 and CAS2 became valid at 08:19:39 UTC
- - CAS3 became valid at 08:19:43 UTC
- - SAT was recorded at -7°C

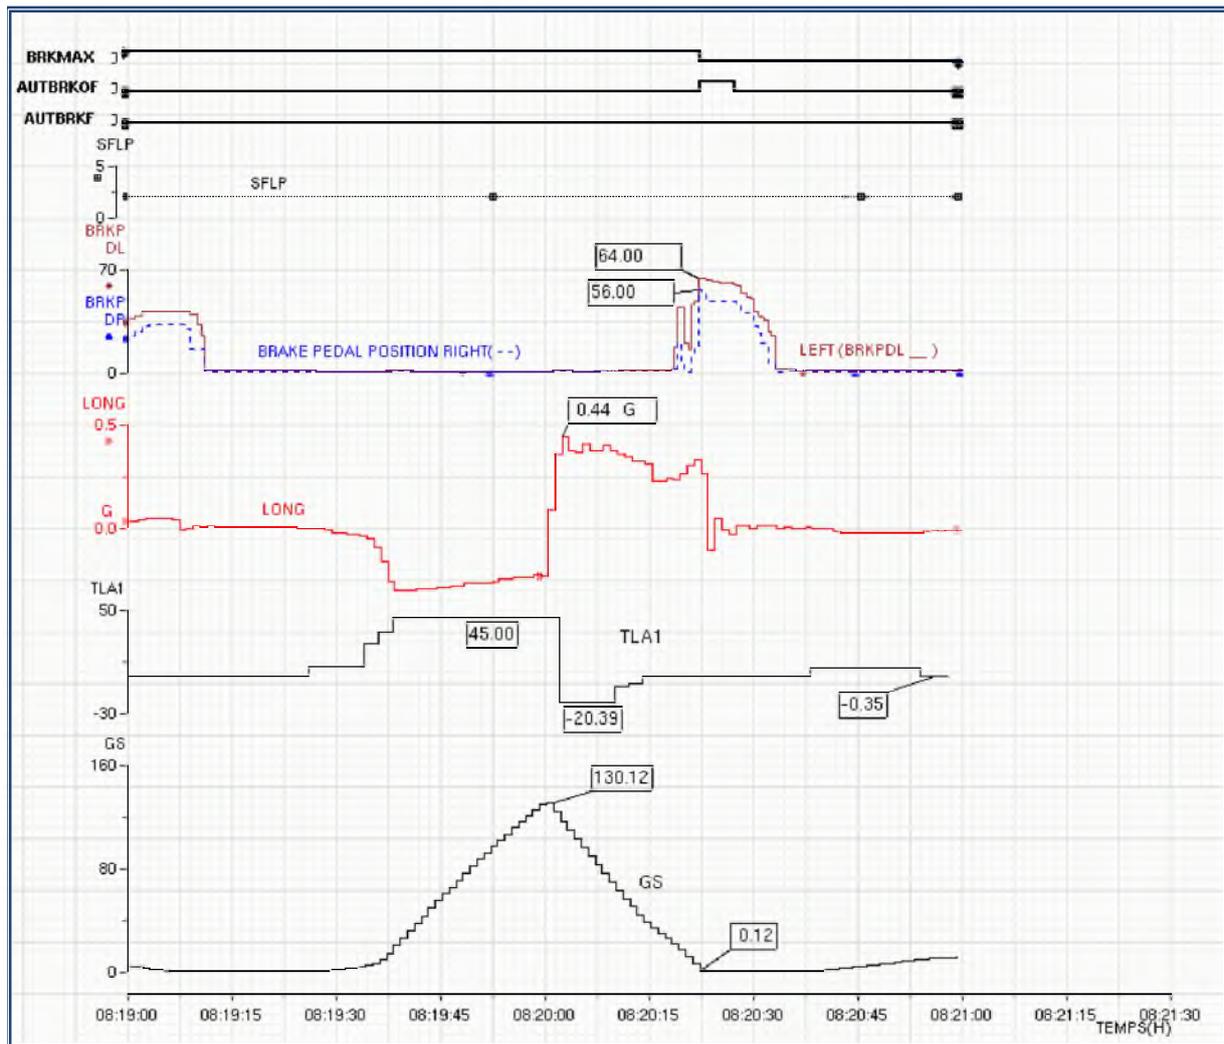
Rejected Take-Off

- - Thrust Levers were set to IDLE notch.
- - Ground speed was recorded at 69kt,
- At 08:20:22 UTC,
- - BRKMAX recorded from 1 to 0
- - Brake Pedal Position left = 64 degA
- - Brake Pedal Position left = 55 degA
- - AUTBRKOF recorded at 1 during 5 seconds
- - A/C stopped (GS=0kt).

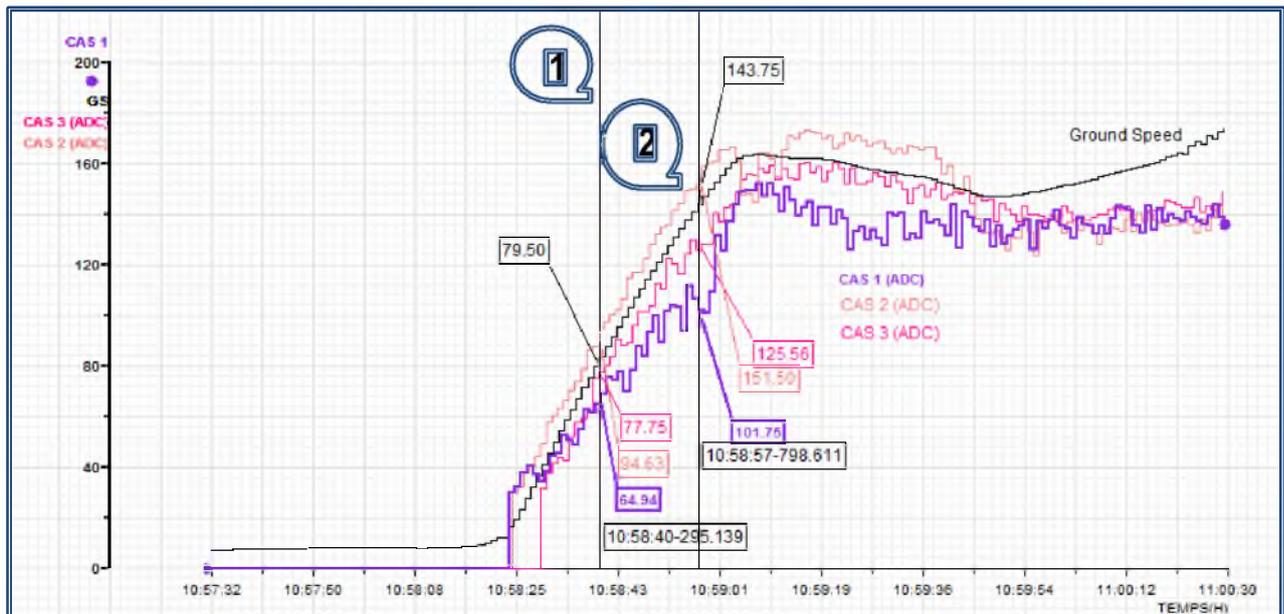
Plotted data / Take-Off

- A/C was aligned on RWY 09 in CONF 2
- TLs were pushed to TOGA notch
- Both FDs engaged in SRS/RWY mode
- A/THR engaged and armed in THRUST mode
- GS and CAS started to increase
- SAT was recorded at -7.5°C
