AIR, MARITIME AND RAILWAY ACCIDENT
INVESTIGATION NATIONAL BOARD
9, Dyakon Ignatiy Street, 1000 Sofia, Bulgaria

Safety Investigation Report

Ref.:
AAIU-2022-03

ACCIDENT, OCCURRED ON AUGUST 8, 2022 BY PARTENAVIA P.66C "CHARLIE" AIRCRAFT, REGISTRATION MARKS LZ-PTS, OPERATED BY THE PILOT OWNER AFTER TAKE-OFF FROM PRIMORSKO AIRFIELD, DISTRICT OF BOURGAS

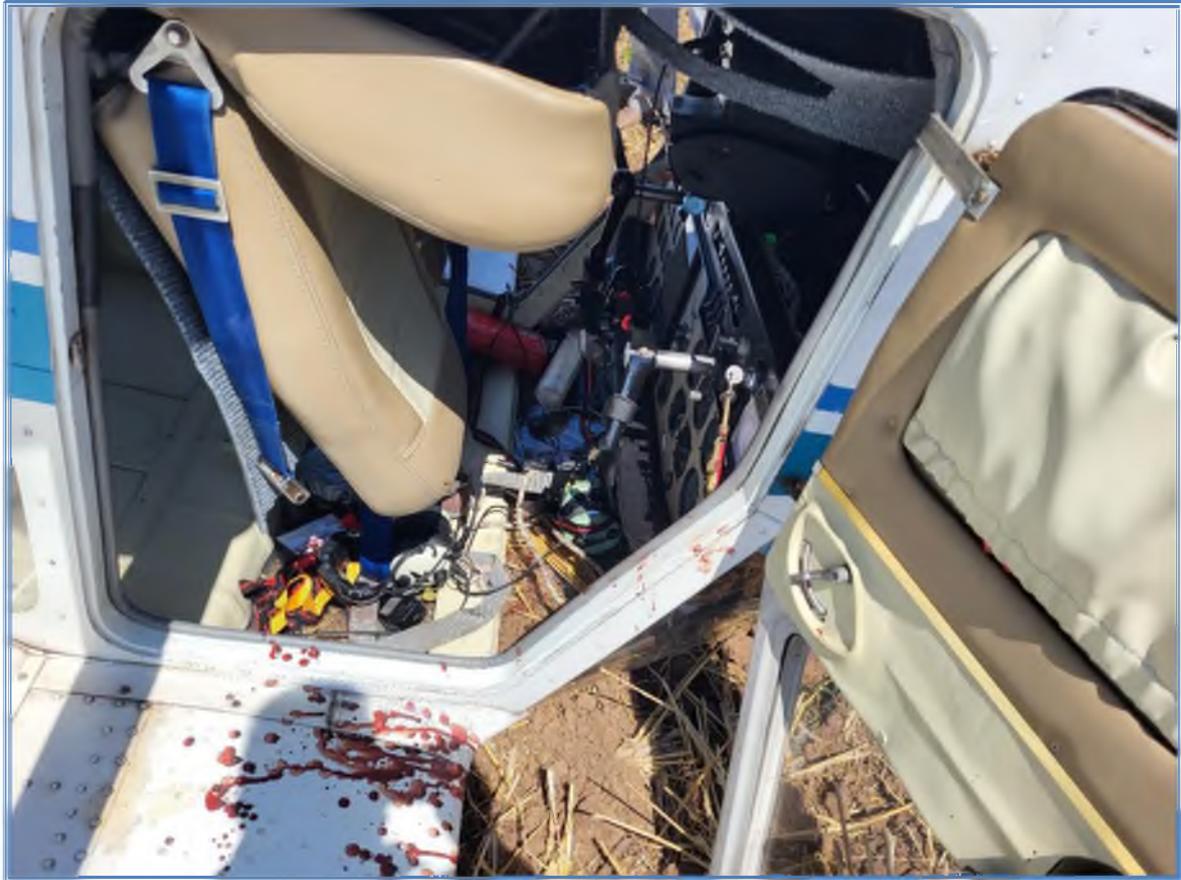
Fig.8.

After detecting a drop in oil pressure, the pilot informed the FIC and took a reverse course to Primorsko Airfield. The oil pressure continued to drop and its temperature rose above the permissible values. The pilot decided to make a forced landing at a site selected from the air. As a suitable one, he selects a harrowed field on the grounds of the village of Krushevets, which he approached at a height of about 1500 ft above the ground, almost perpendicular to the furrows, turning off the engine by the main switch. In the final stage of the approach, when the speed was in his judgment close to stalling, he noticed a wire fence, fails to fly over it and it caused the aircraft to overturn (nose over) and slide on its back to the final stop (Fig. 1 - 7 of Enclosure 1). It can be seen from the photos, that the structural integrity of the aircraft was preserved during the impact. The resulting damages are described in a protocol attached to the investigation file and reflected in paragraph 2.3 of this report. Upon impact with the ground surface, the pilot received a cut wound on the left-hand side of the head caused by the aluminium cockpit ventilation diffuser (Fig. 8 of Enclosure 1).
