# FINAL REPORT

Investigation of a serious incident on 30.06.2015 with FALCON F900 aircraft, registration marks VP-CGD, and EMBRAER 170 aircraft, registration marks SP-LDK, started in the controlled air space of the Republic of Romania and realized in the controlled air space of the Republic of Bulgaria.

2016

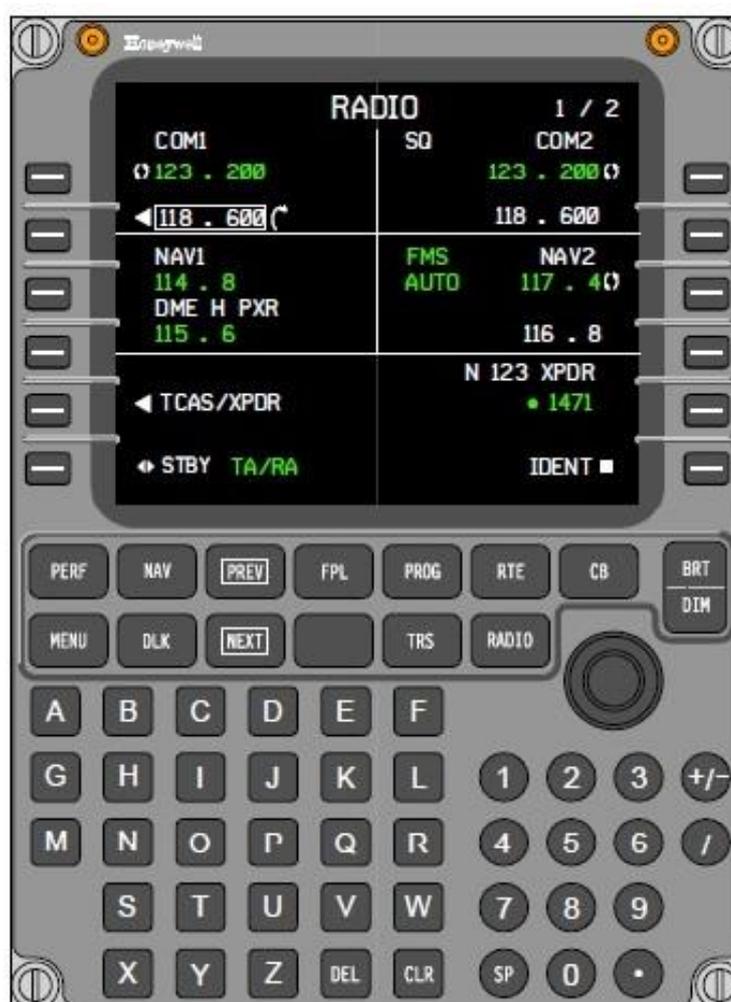
**Fig. 8**

The transponder system of Embraer-170 aircraft is controlled by two MCDUs (Multifunction Control Display Units) located on the Engine Start Panel (see Fig. 8).

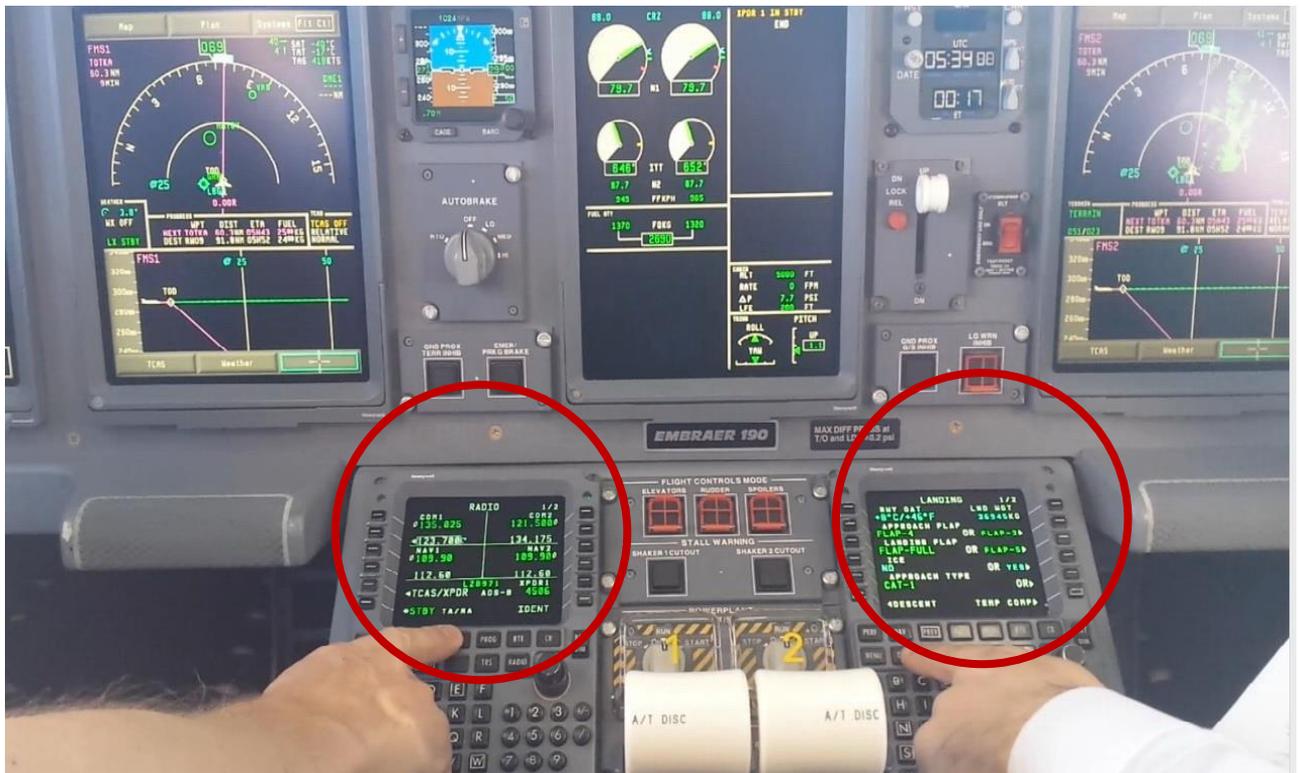
Fig. 9

The one MCDU is located on the right side of the Captain Pilot Flying, and the other one is located on the left side of the First Officer, as seen on Fig. 9.
