# FINAL REPORT

investigation of an aviation accident, realized on 27.07.2015 with aircraft P92-JS, registration marks LZ-DBV, in the region of Dolna Banya airfield

2015

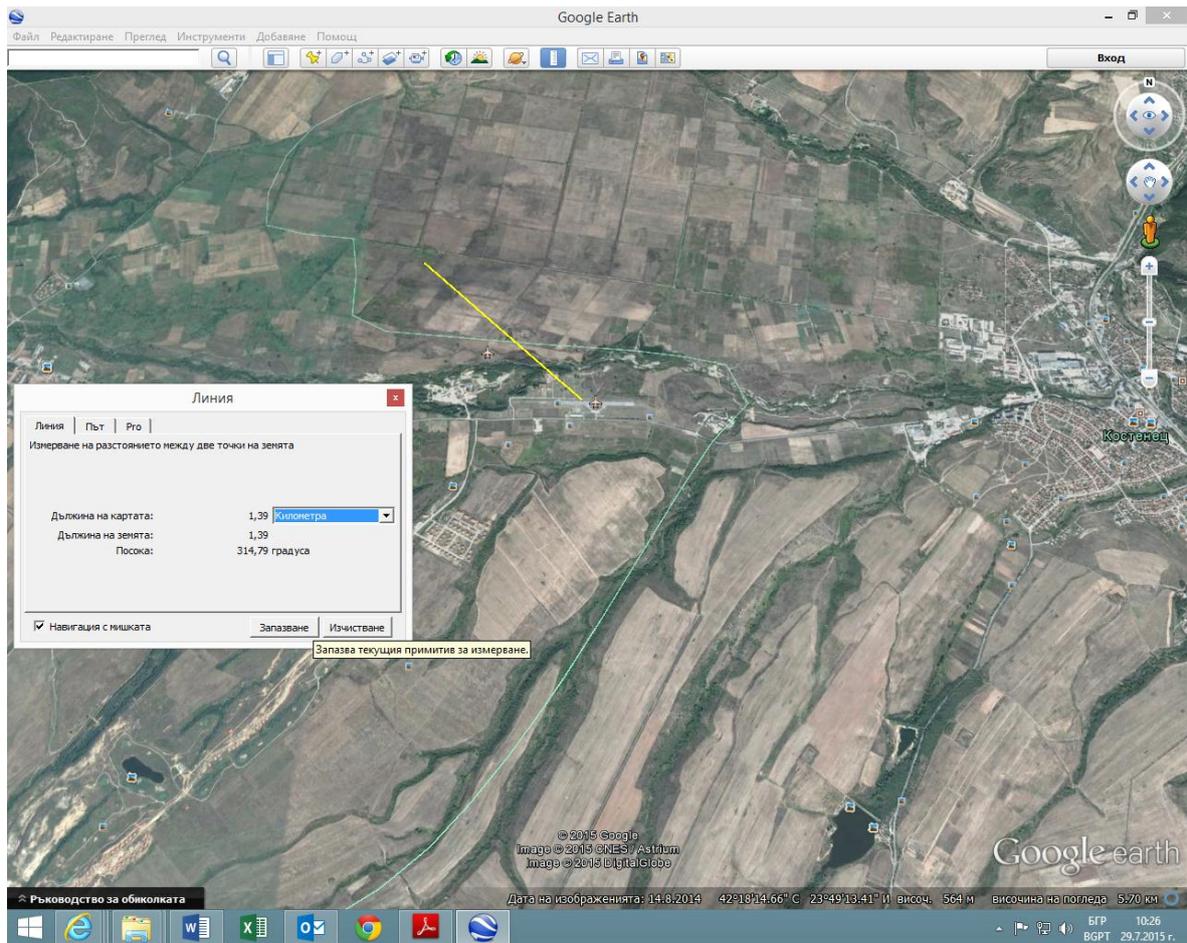
Figure 1.

Exercise was to be simulated. It is located at 1,39 km in the north-western direction from the center of RWY of “Dolna Banyá” airfield on a straight line, as exhibited on the photo on Figure 1, Appendix 1, made on a Google map. Figures 3, 4 and 5 of Appendix 1 provide photos of the place. The coordinates of the aircraft’s nose at the place of the accident are: N 42° 19’ 06,15”, E 23° 48’ 23,56”, and the altitude is 559 m.

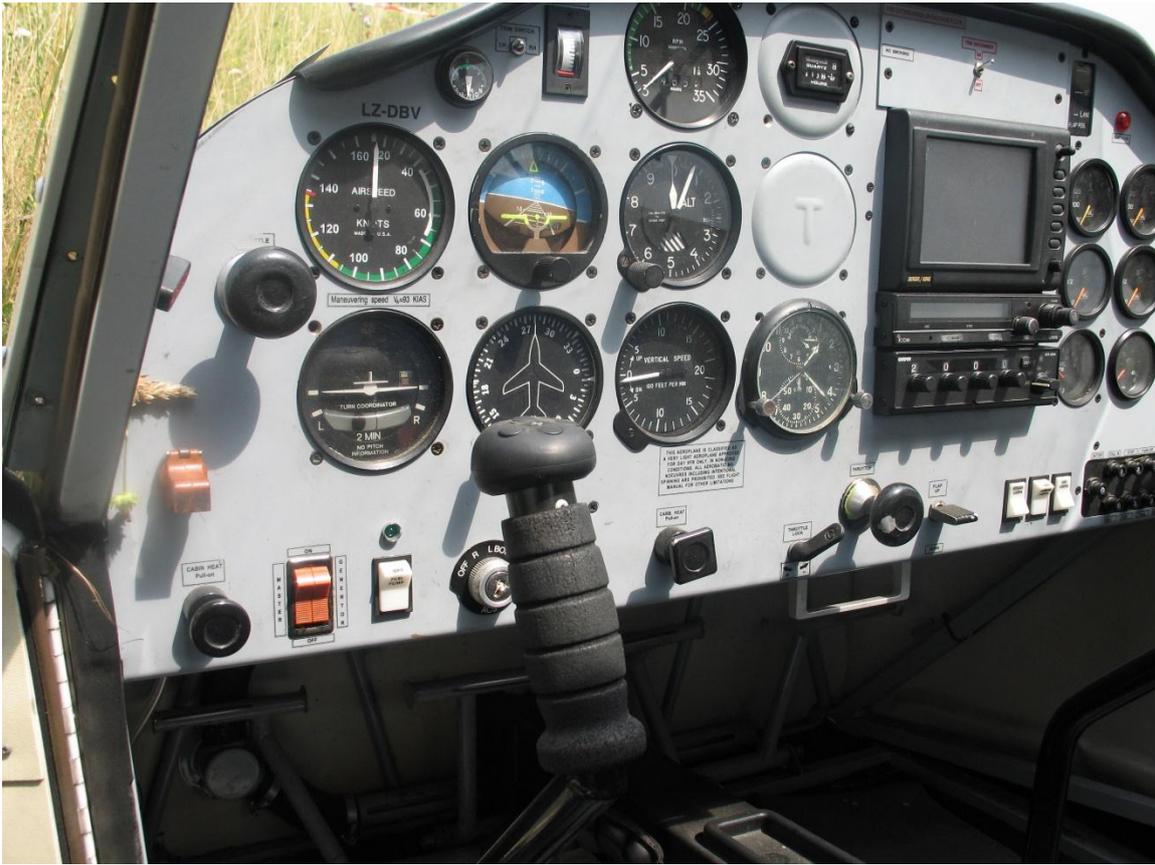
Figure 7.

The above findings are illustrated by photos on Figures 7 and 8 of Appendix 1.

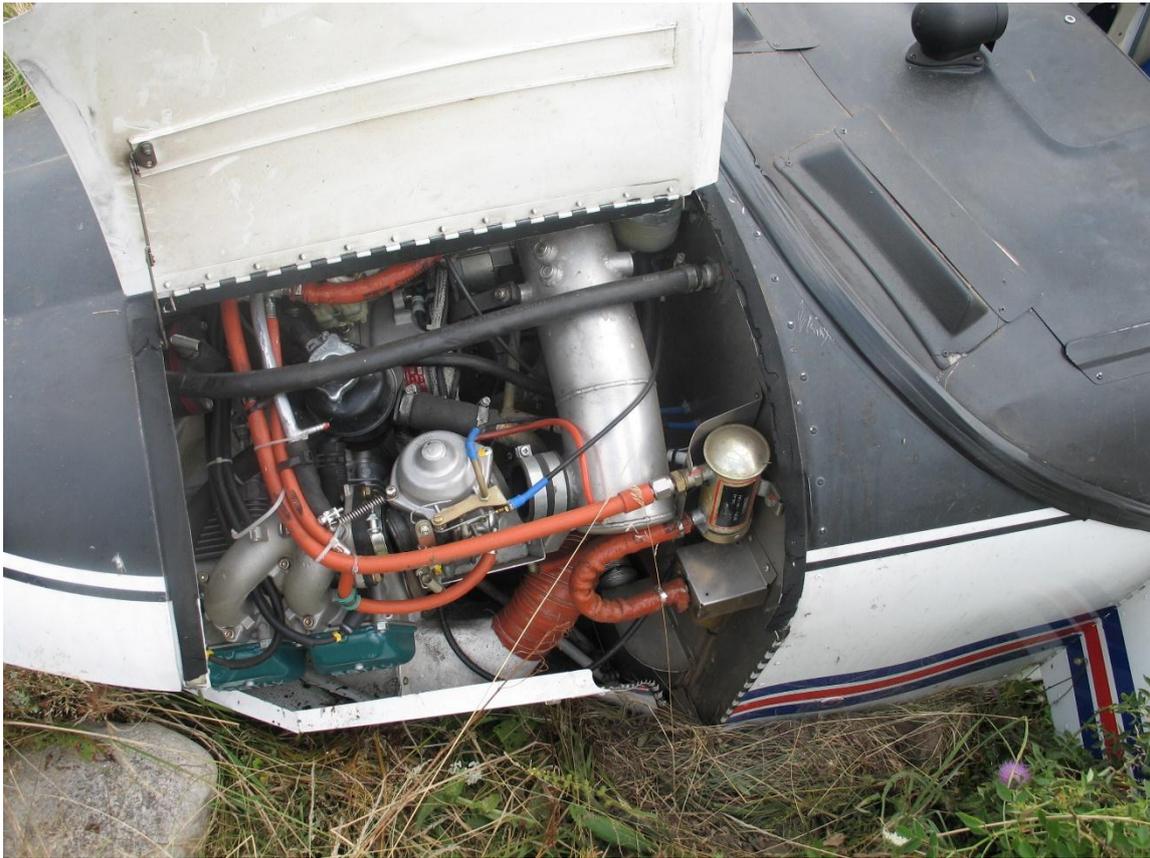
Figure 15.

- Deformation of fixing units of left L/G and left strut, Figure 13, Appendix 1.
- Deformation and destructions on the edge of the left semi-wing, the shielding is destroyed on its bottom side, Figure 14, Appendix 1.
- The stings controlling the valves of the left and right carburetors are not damaged, Figures 15 & 16, Appendix 1.
- There is no visible tearing of pipes in the engine compartment.
- Destroyed oil radiator.
- Oil in the engine is within the norms between 2 and 3 l.
- On the left side of the body in front of the horizontal stabilizer, aircraft identification panels are fixed, Figure 17, Appendix 1.
